**CONSENT ORDER
ISSUED UNDER THE
WATER POLLUTION CONTROL ACT
WEST VIRGINIA CODE, CHAPTER 22, ARTICLE 11**

TO: Mountain Valley Pipeline, LLC
Attn: Robert J. Cooper
Senior Vice President, Engineering and Construction
625 Liberty Ave, Ste 1700
Pittsburgh, PA 15222

DATE: April 19, 2019

ORDER NO.: 8951

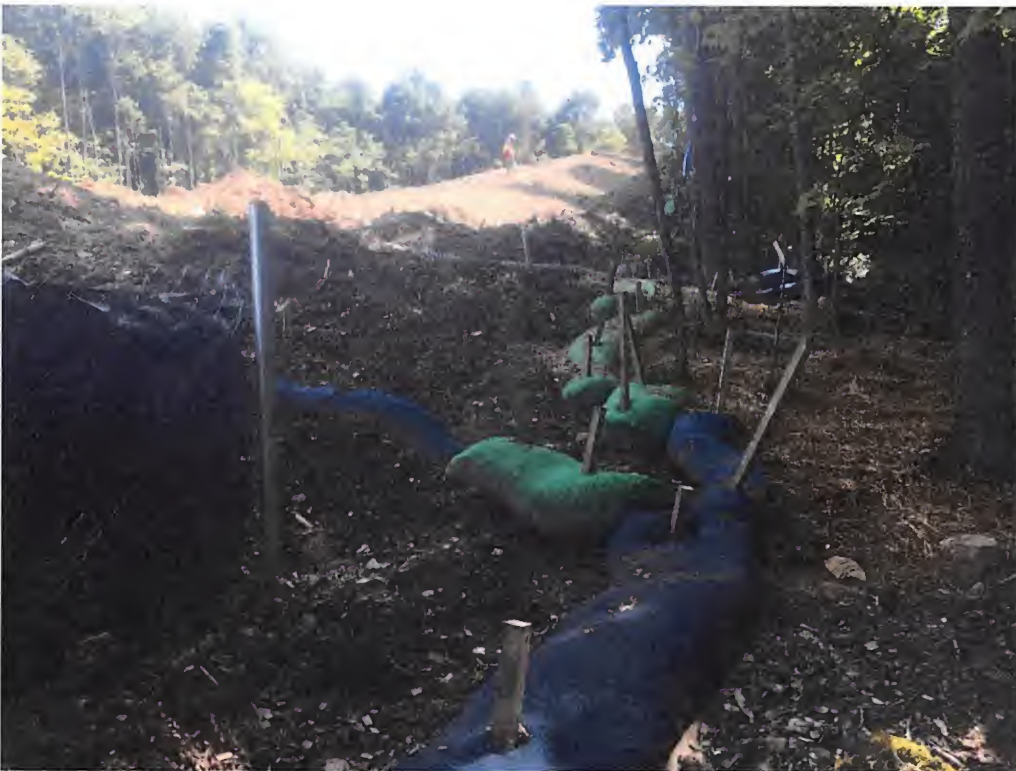
Photo 22: Failure of installed water bars between stations 7084+00 – 7093+50.

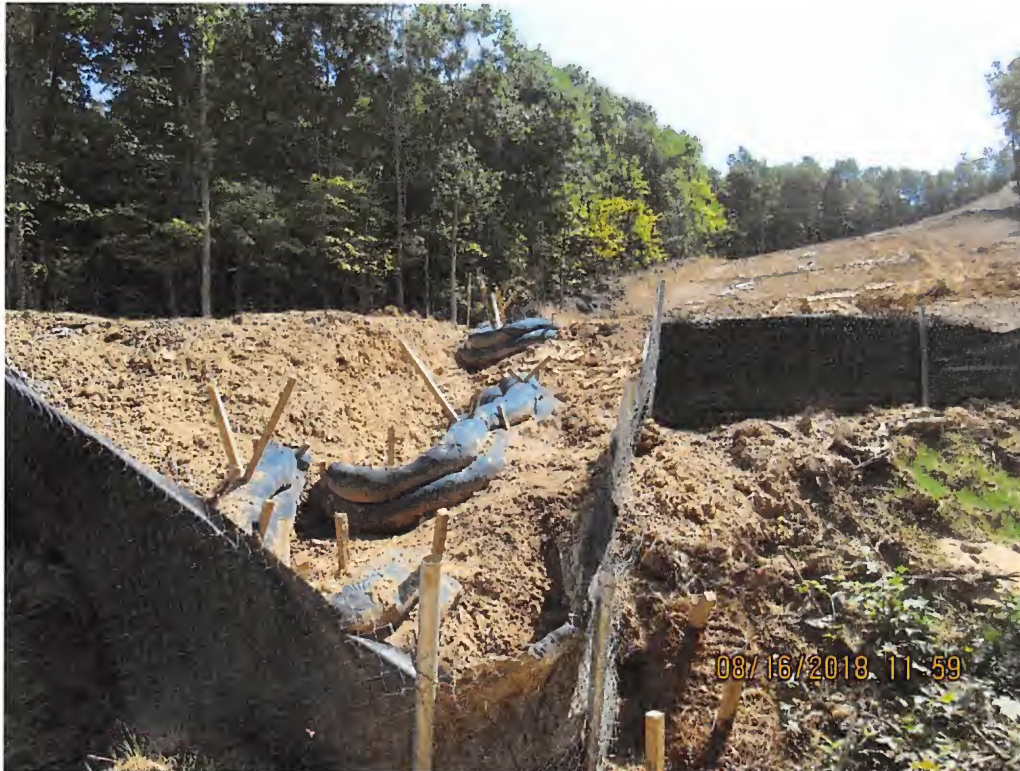
Photo 23: Water bar terminus at station 7084+00 with ROW slope of Photo 21 in background.

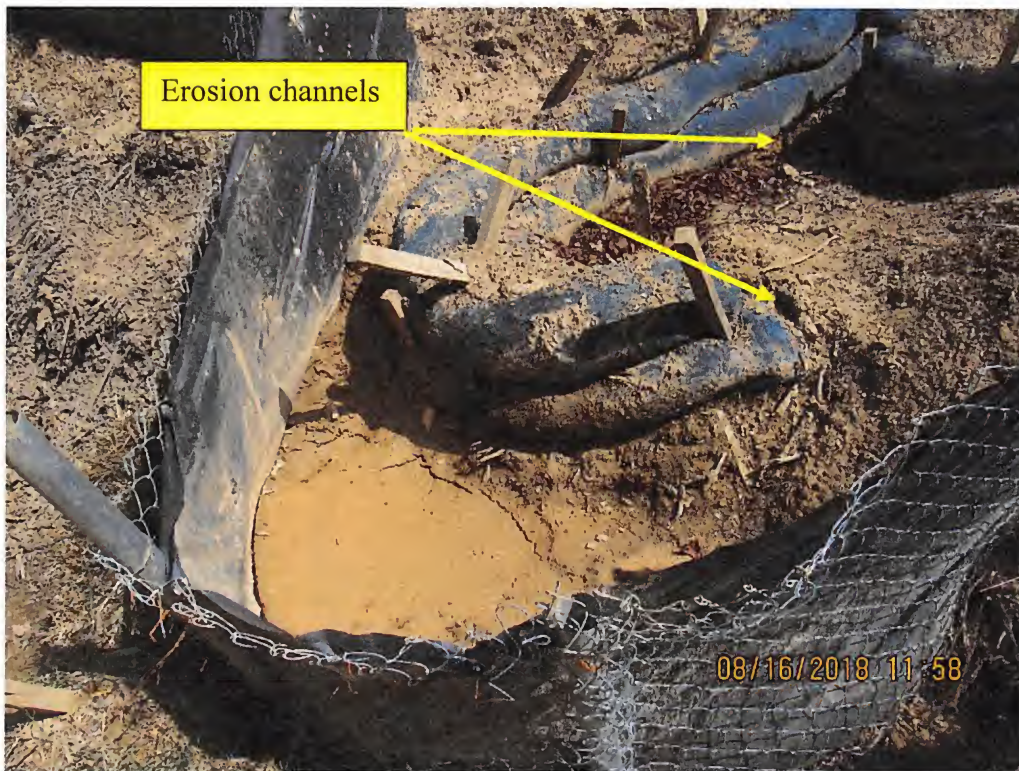
Photo 24: Water bar terminus at station 7084+00. Erosion channels observed at ends of CFS.

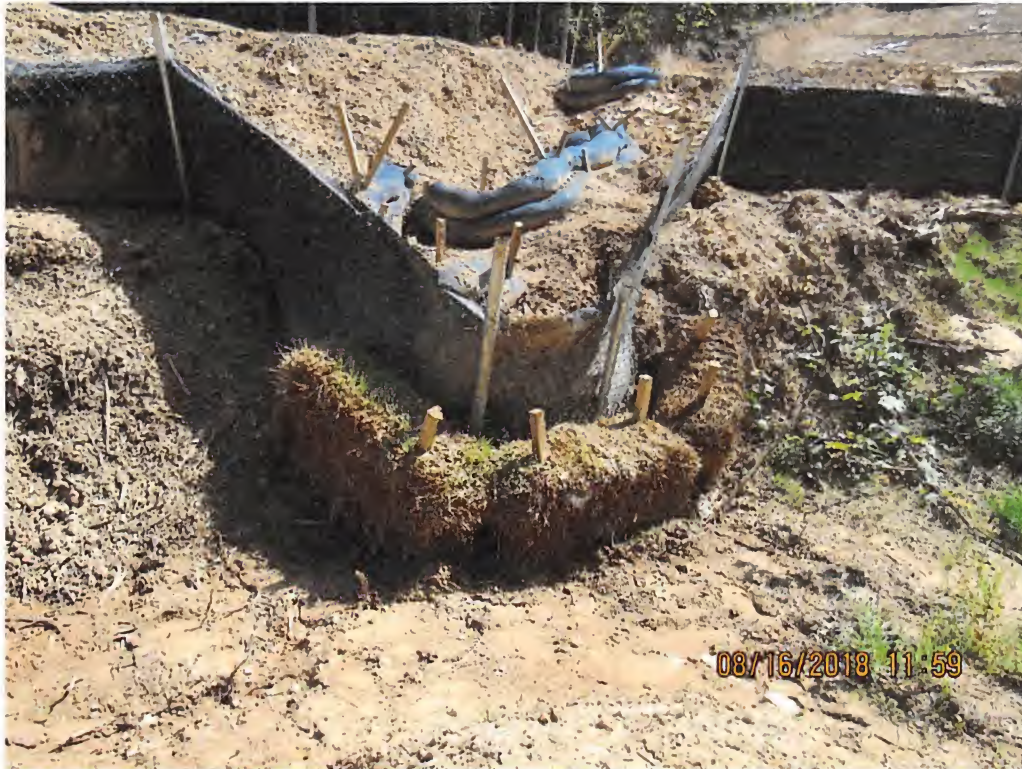
Photo 25: Controls and sediment deposits in road side ditch at water bar terminus at station 7084+00.

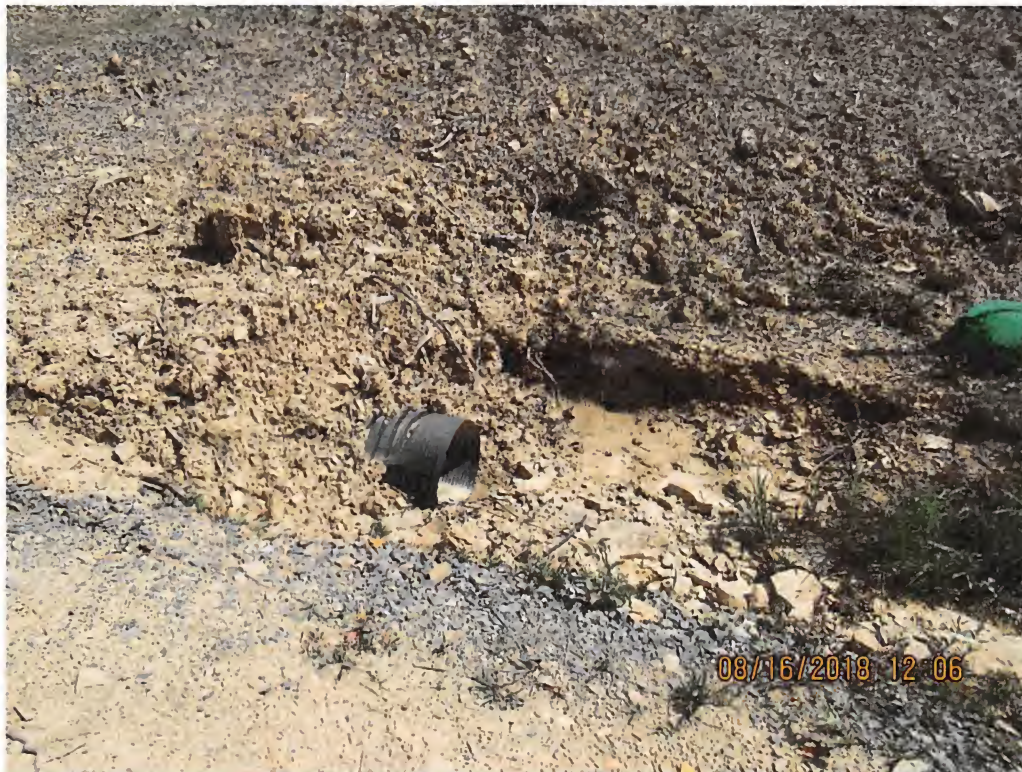
Photo 26: Road side ditch below water bar terminus in photos 23-25 conveying sediment laden water to installed culvert.

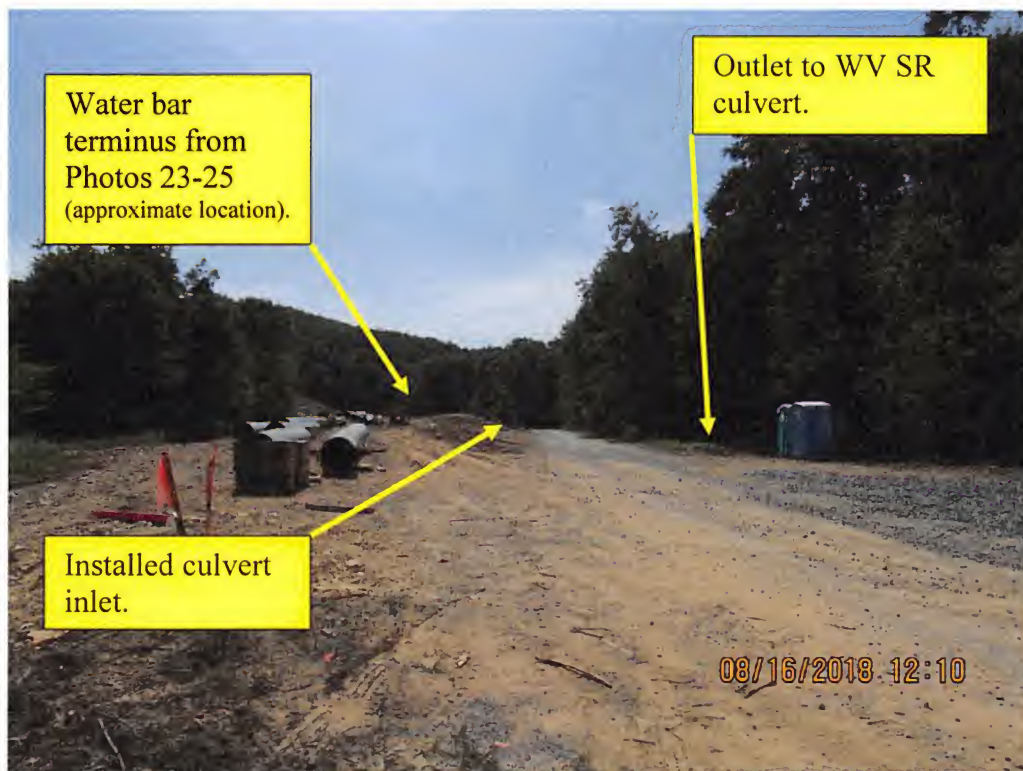
Photo 27: Installed culvert inlet near 7080+00 conveying sediment laden water from water bar terminus in photos 23-25 to SR culvert.

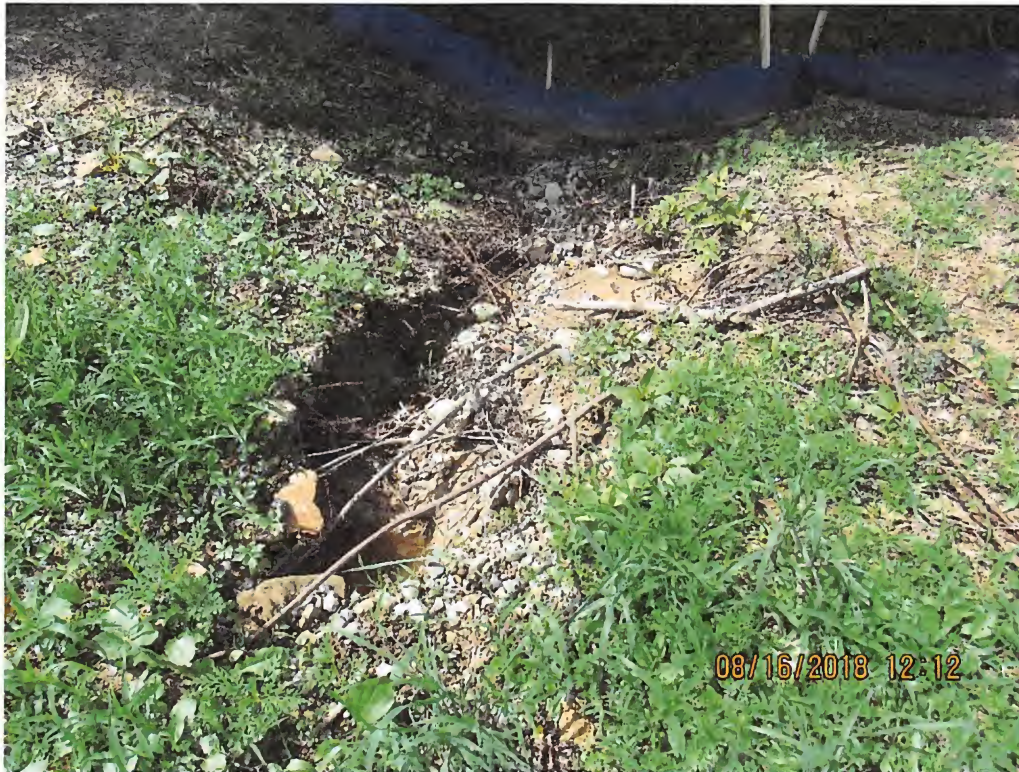
Photo 28: Relative distance of failed water bar terminus, culvert inlet and SR culvert outlet.

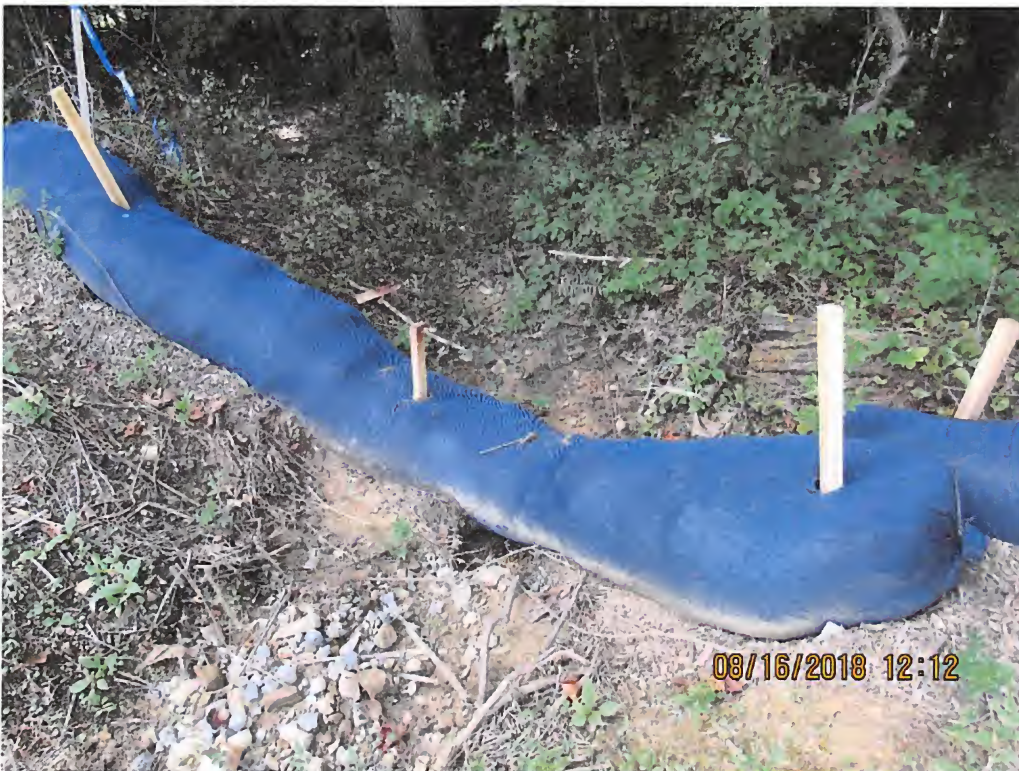
Photo 29: Outlet to SR culvert connected to installed culvert in photo 27.

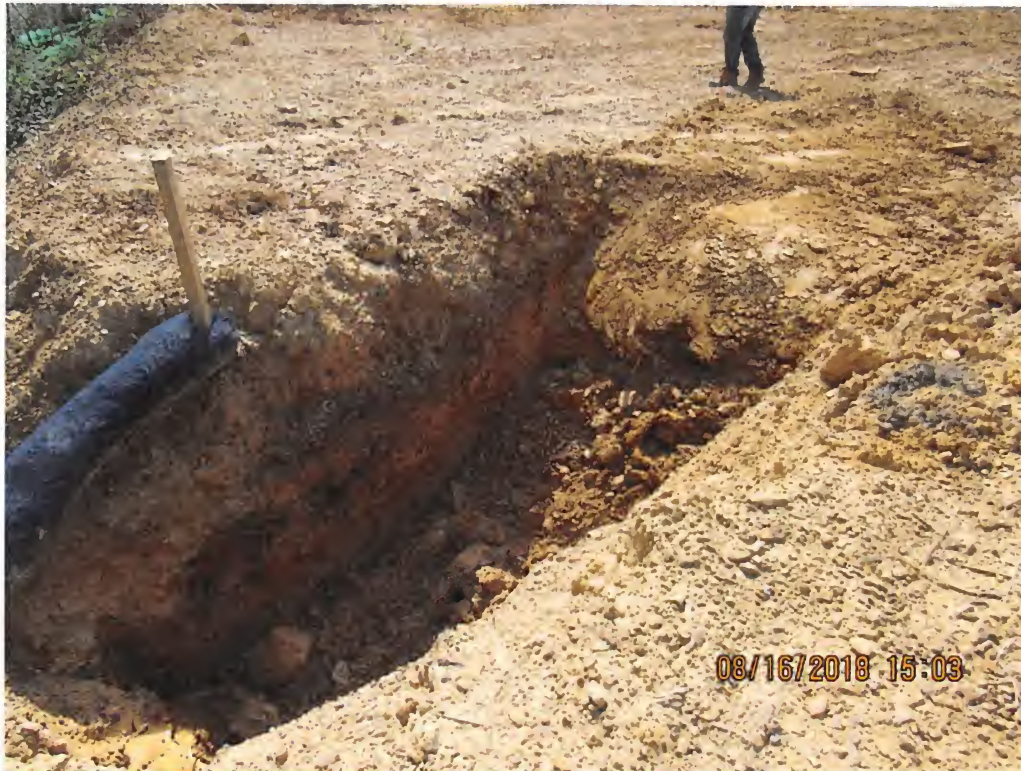
Photo 30: Perimeter controls failure downslope of SR culvert outlet allowing sediment laden water to leave site.

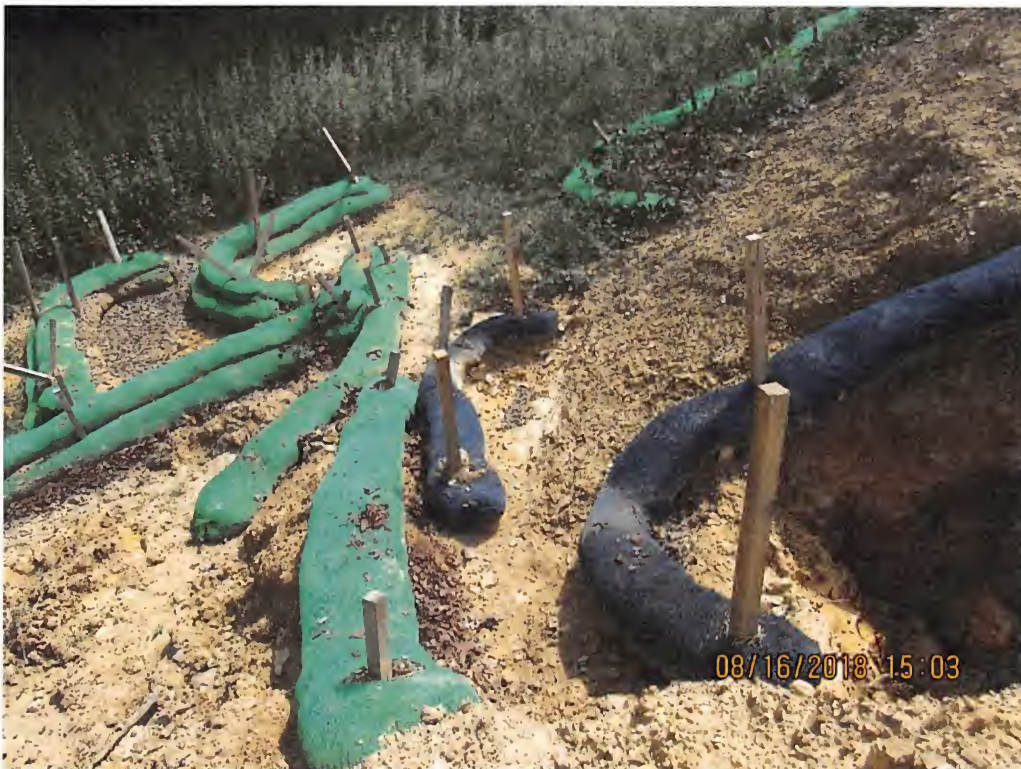
Photo 31: Sumps installed at terminus of water bars near Wahoo Road station 6781+51 which has reduced failure.

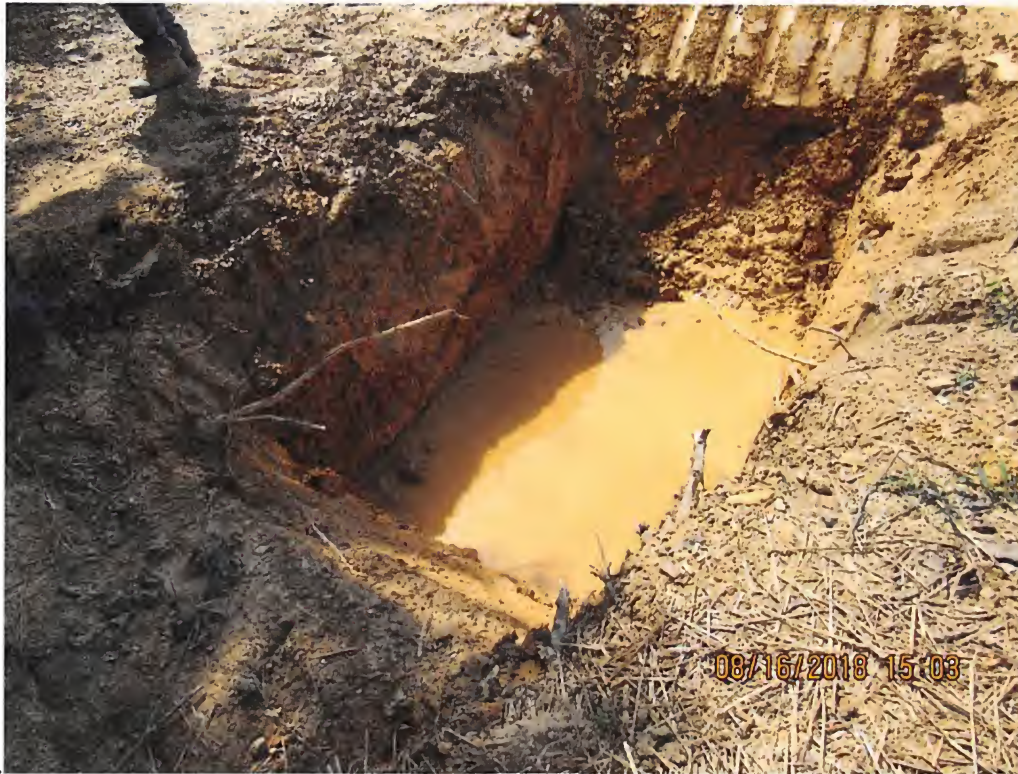
Photo 32: Site of historical water bar terminus control failure- sump installed has reduced failure.

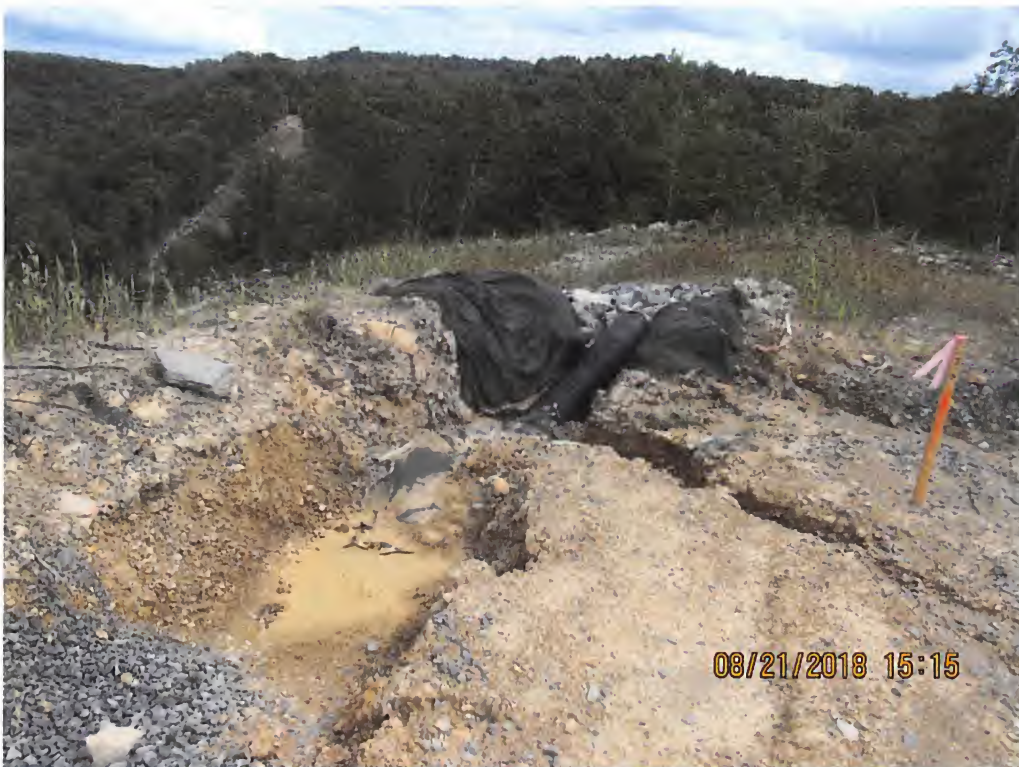
Photo 1: Unfinished underdrain installation.

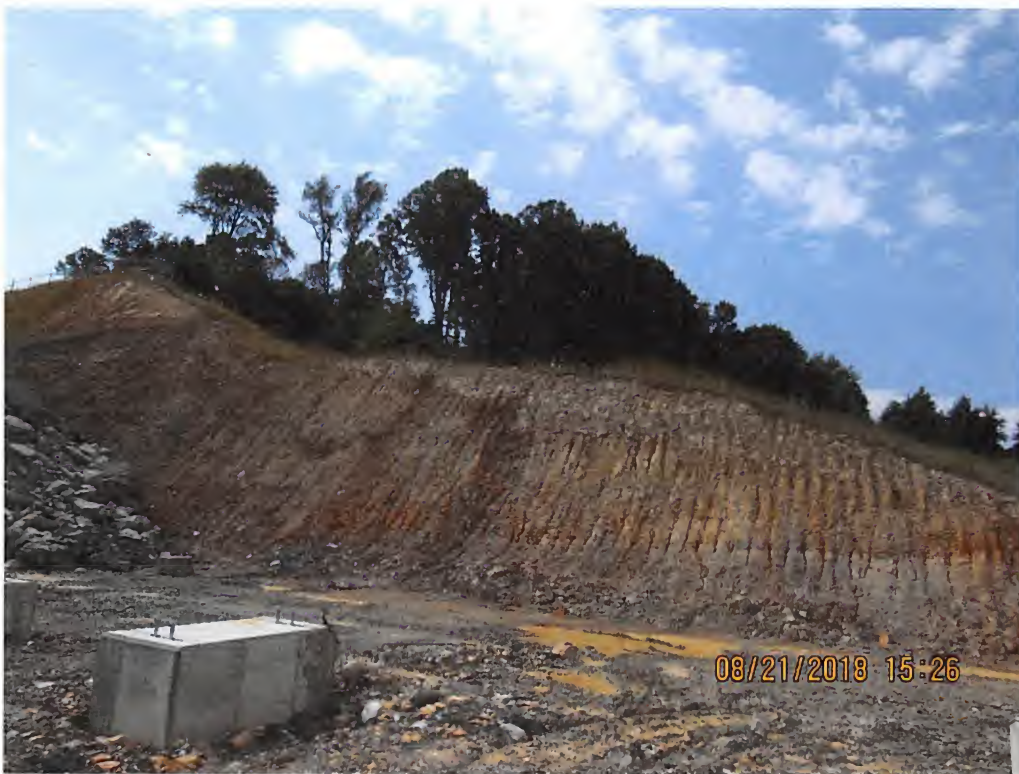
Photo 3: Slope on northwest side of site which has not been reseeded.

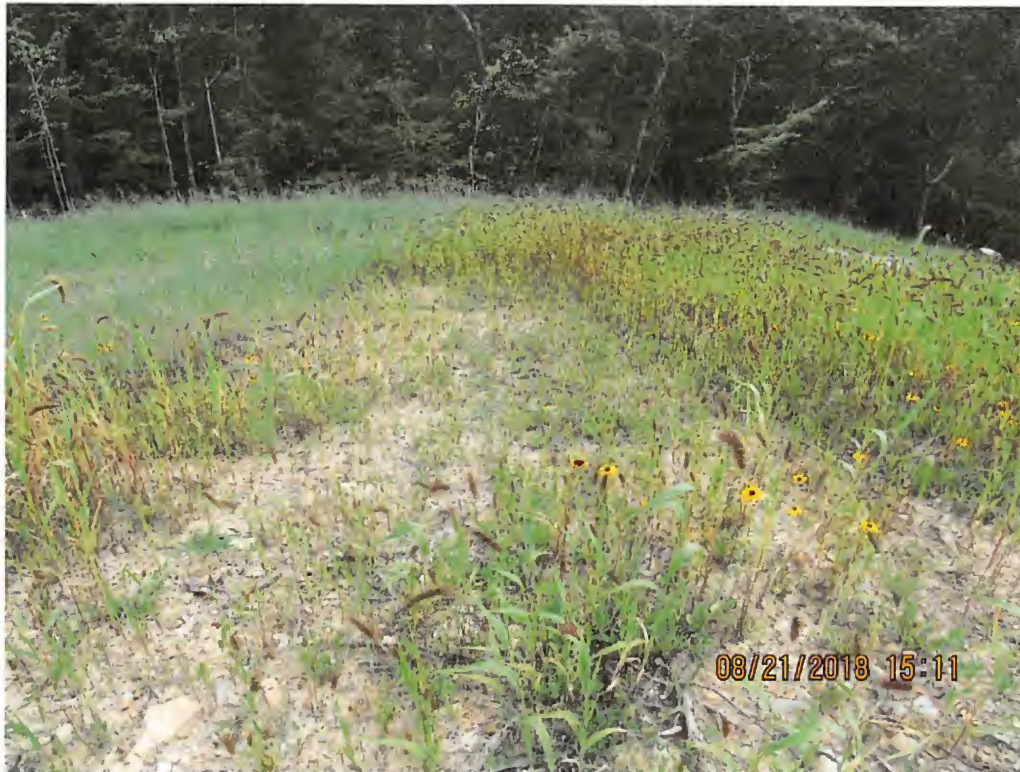
Photo 4: Slope on northwest side of site which has not been reseeded.

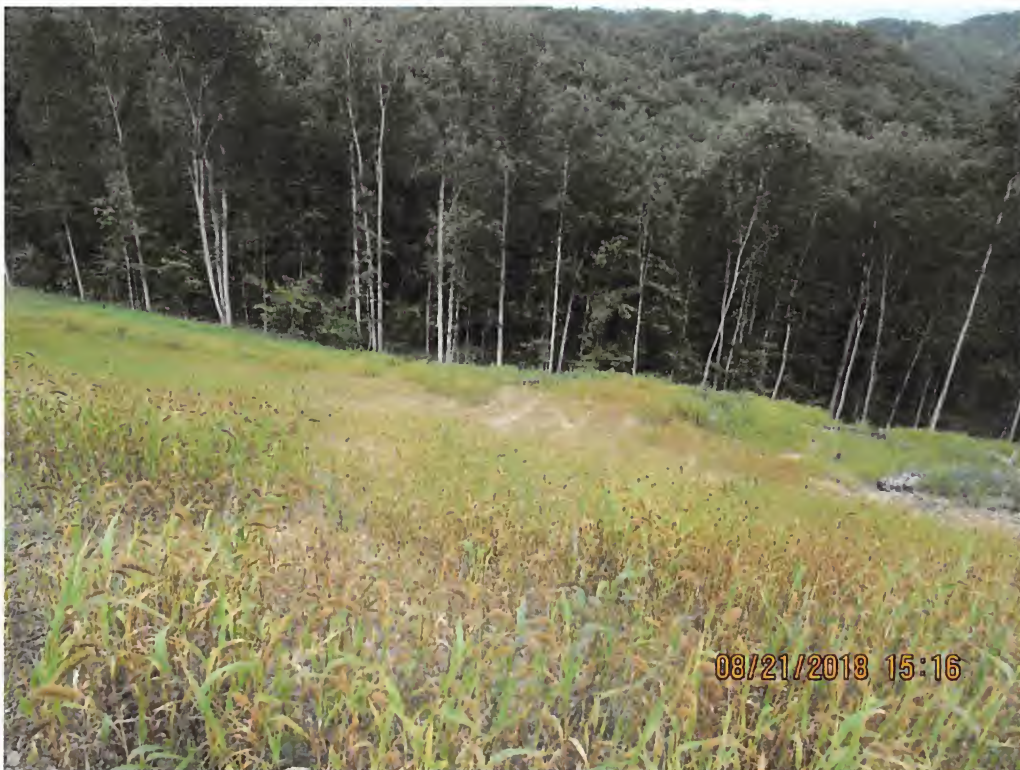
Photo 5: Area reseeded but growth not observed due to lack of sufficient rain.

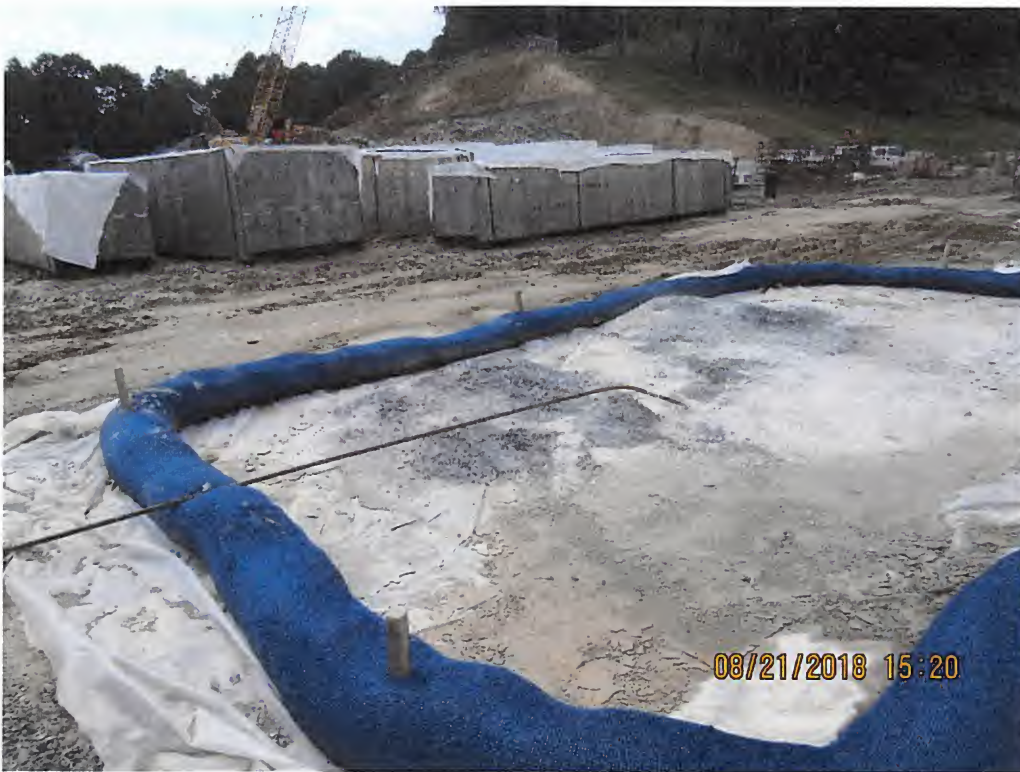
Photo 7: Improperly implemented control for concrete wash out area.

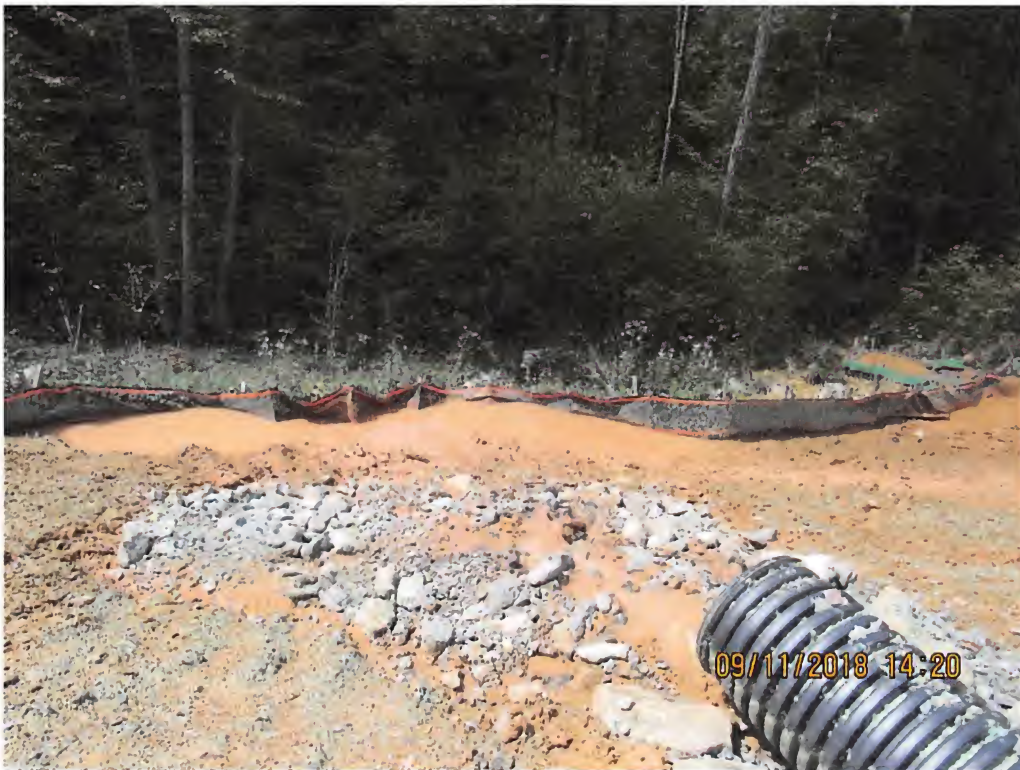
Photo 5: Station 150 (approximately)- controls maintained abating NOV issued 8/13/2018.

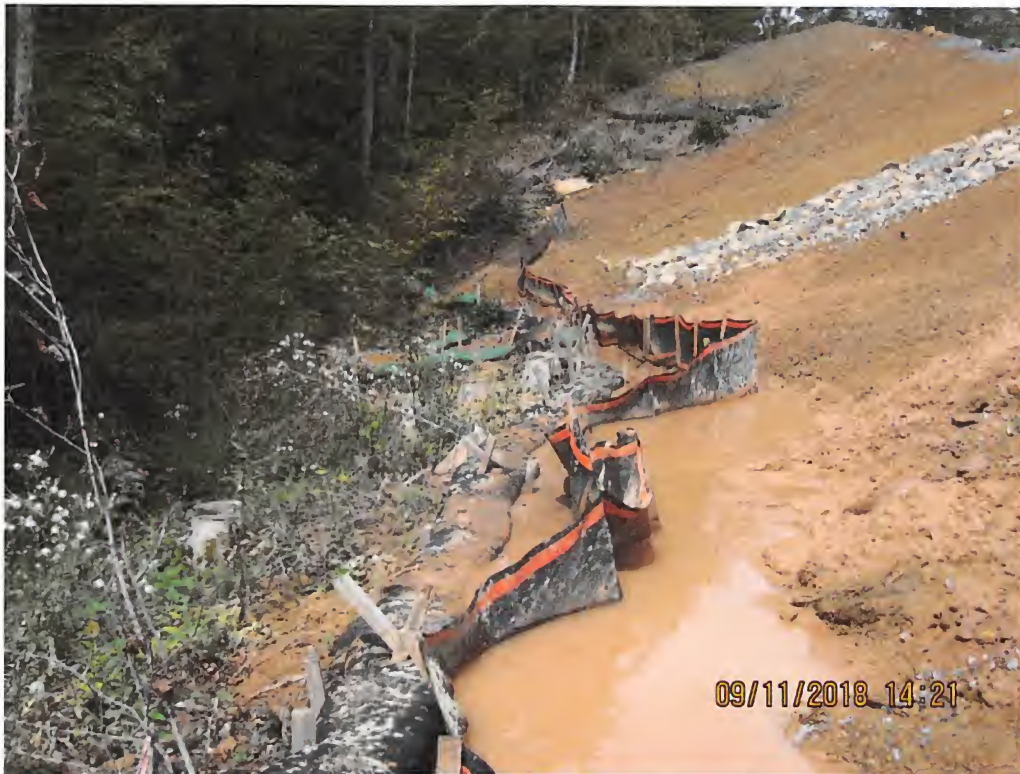
Photo 6: Station 900- Culvert outlet concentrating flow from diversion ditch.

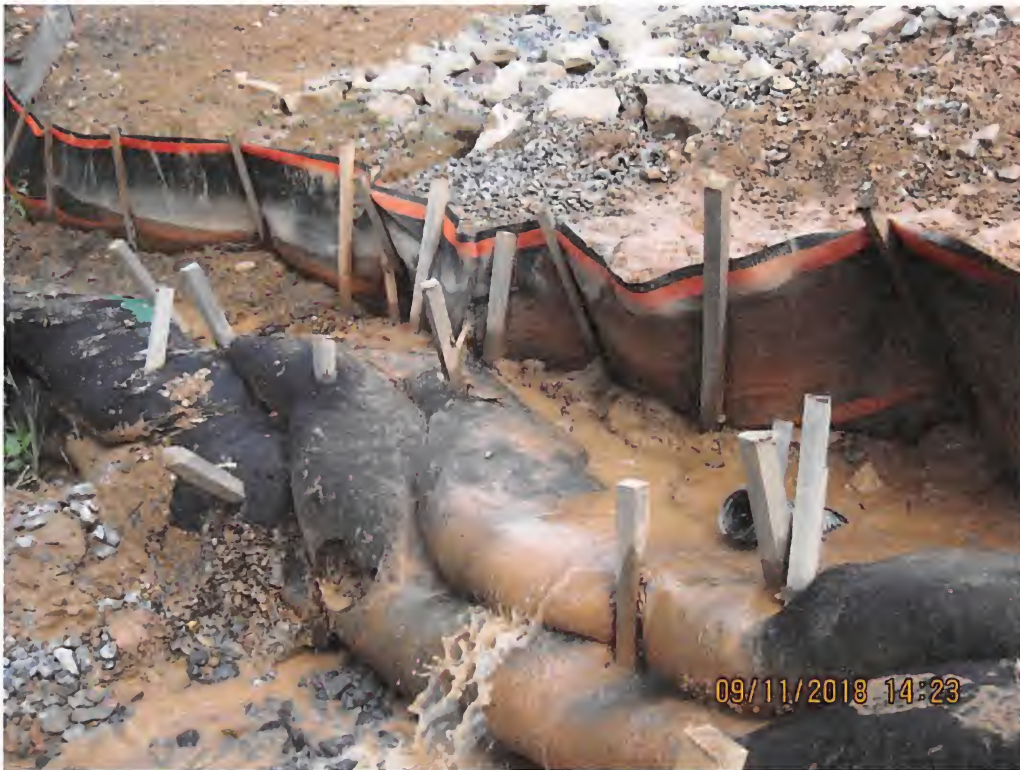
Photo 7: Station 900 (approximately) -Flow along silt fence from culvert outlet downslope to sump.

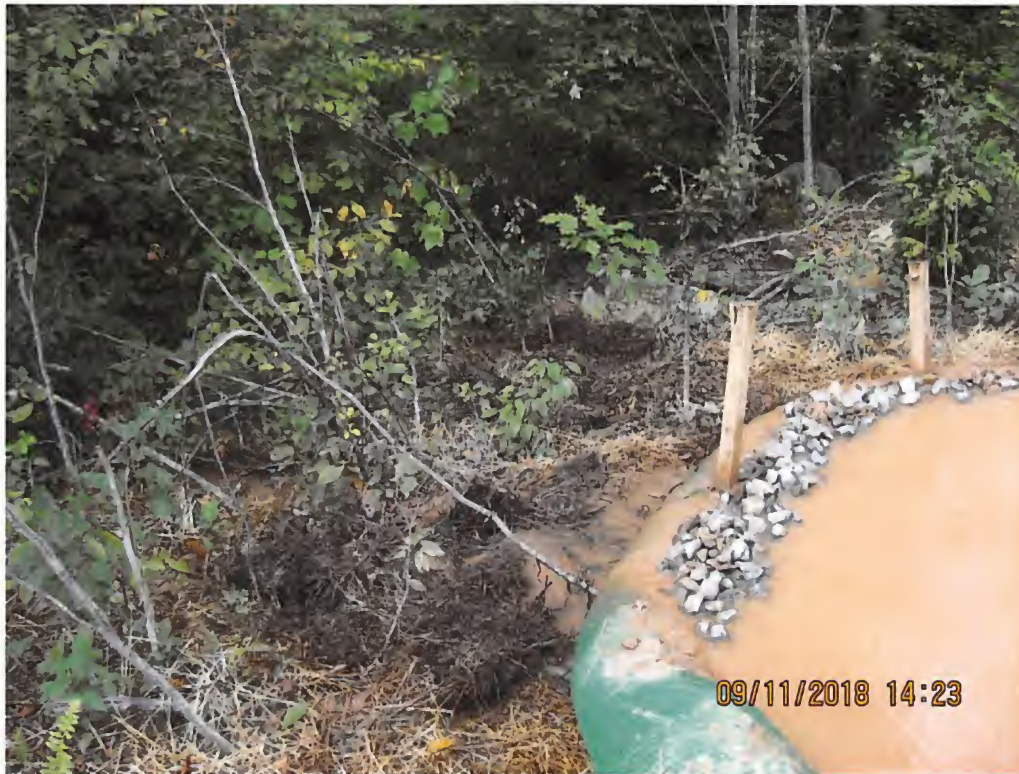
Photo 8: Station 900 (approximately)-Flow below silt fence into sump.

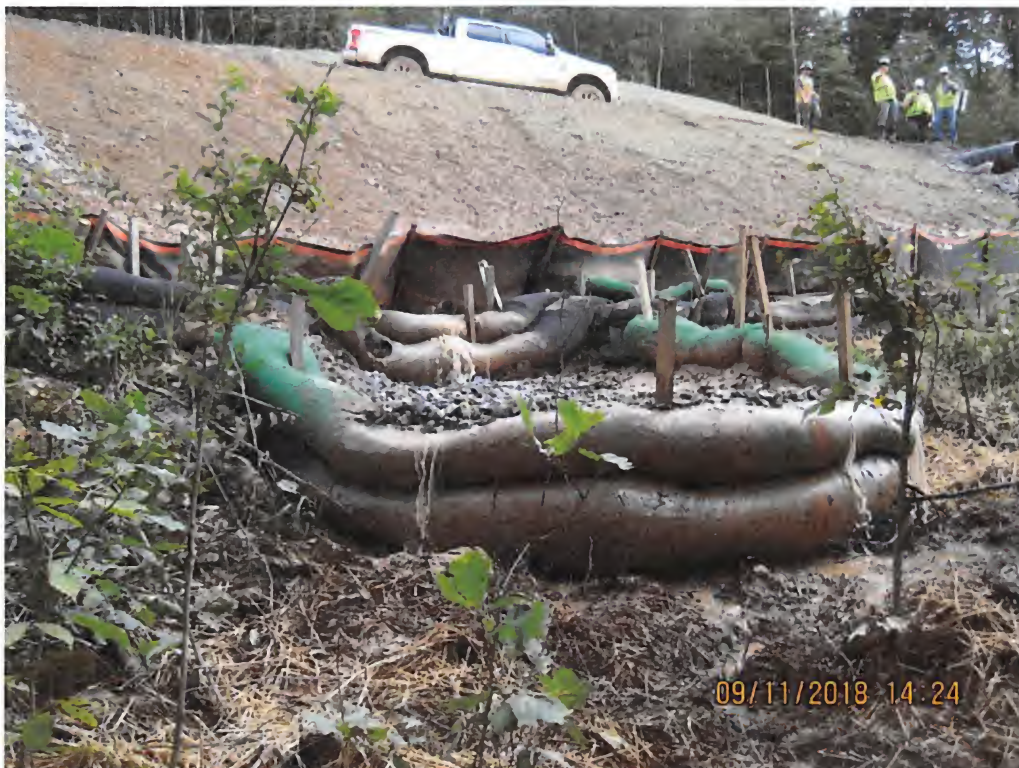
Photo 9: Station 900 (approximately)- outlet of sump below photo 8 with sediment laden water leaving site view down gradient.

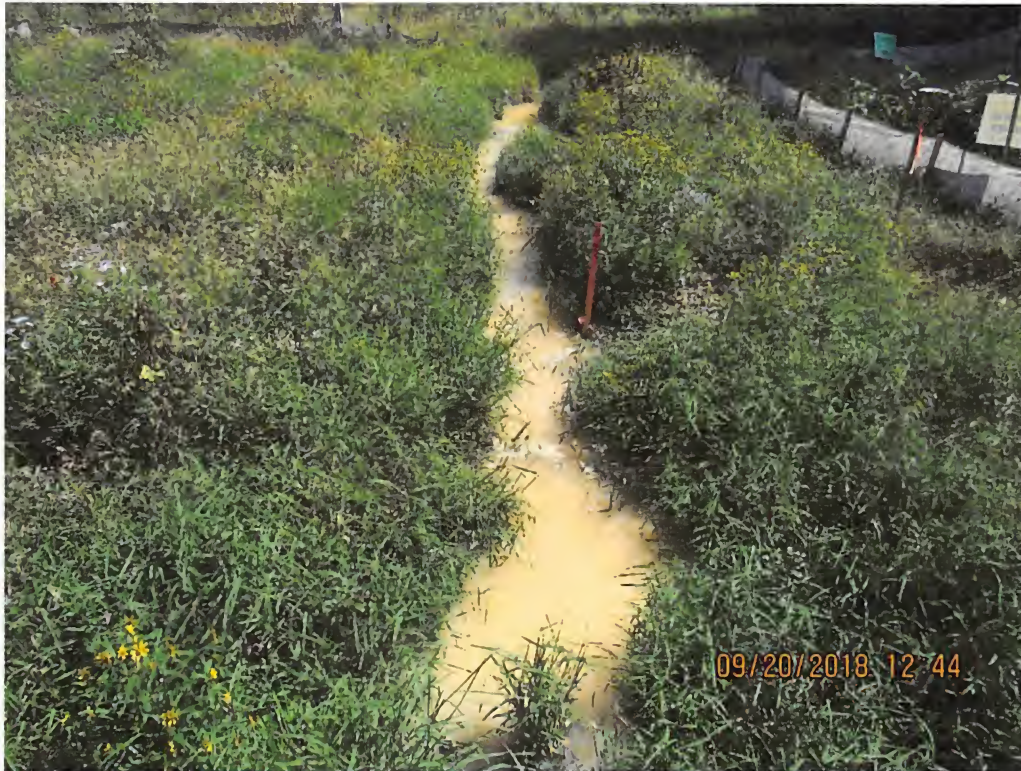
Photo 10: Station 900 (approximately)- upslope view of controls and sediment laden water leaving site.

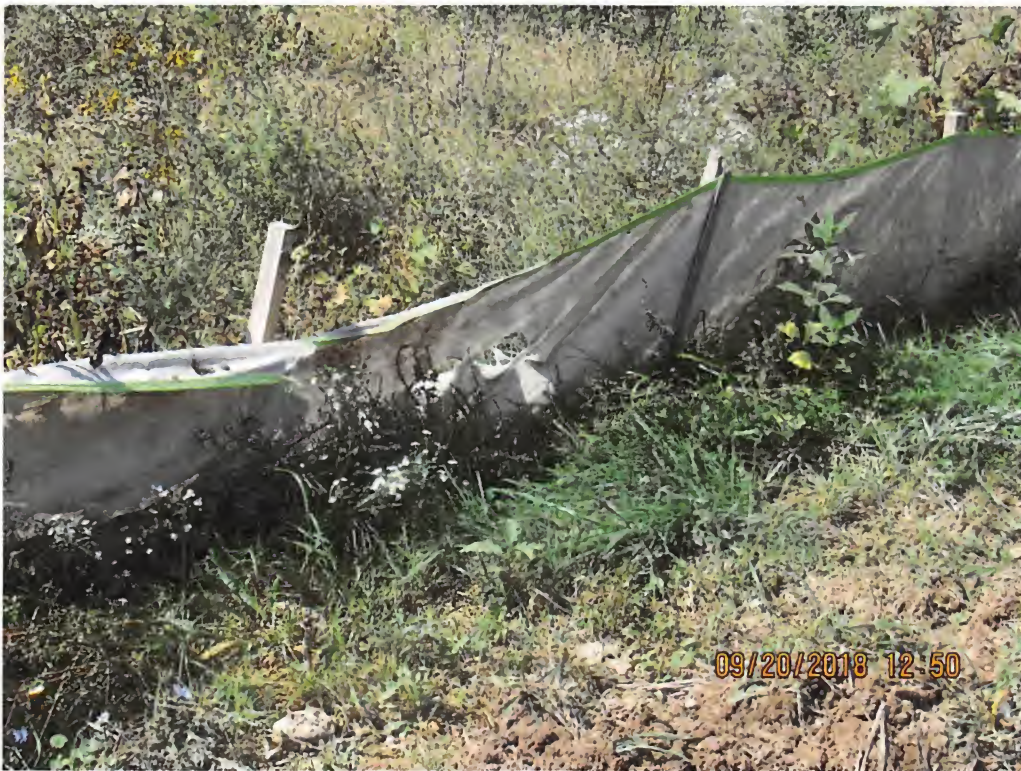
Photo 1: Plume in UNT of Painters Run from control failure off access road 231.01 near station 10270+49.

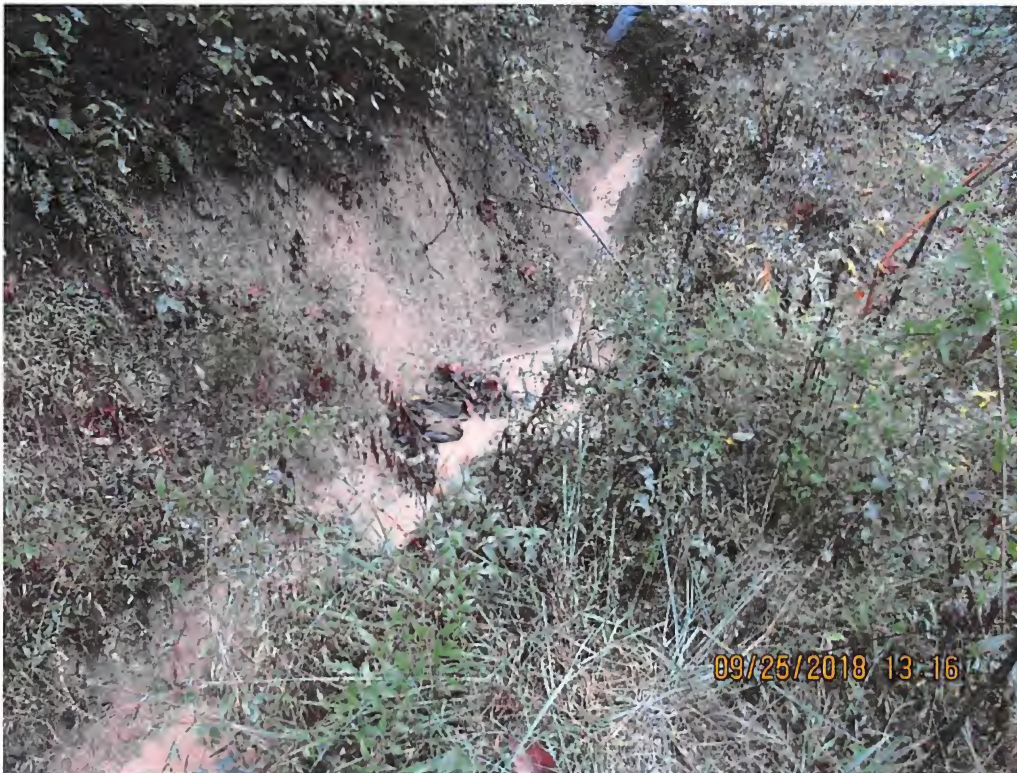
Photo 4: Sump above control failure off access road 231.01 near station 10270+49 Painters Run.

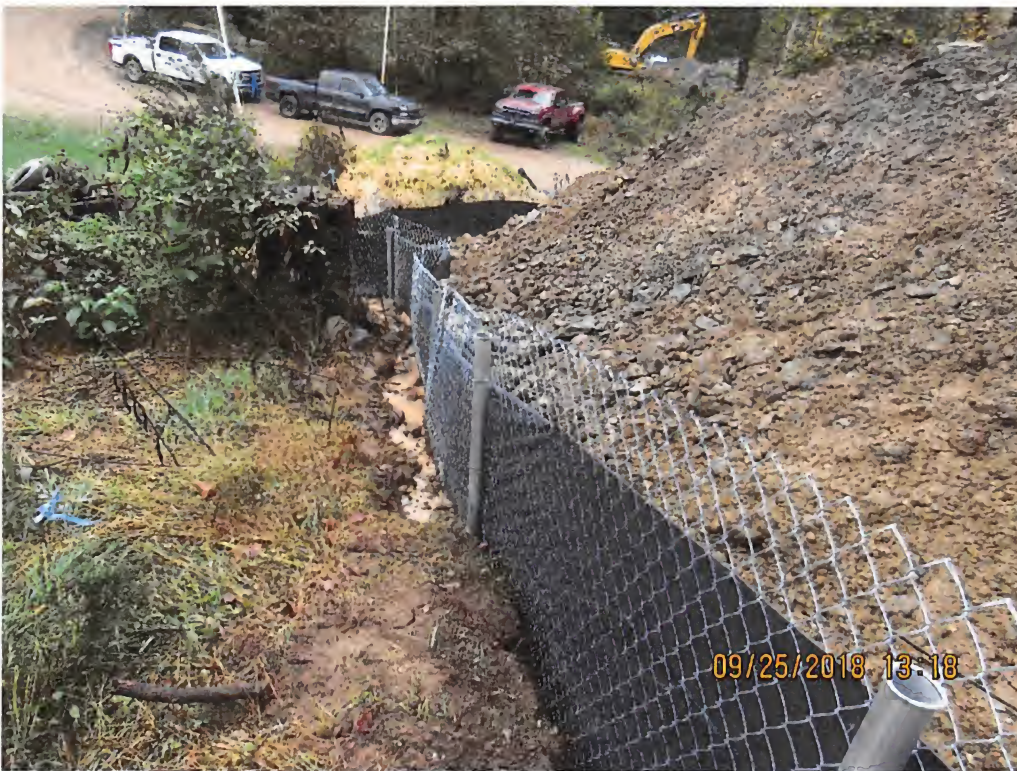
Photo 1: Sediment laden water from sumps near station 3625+00.

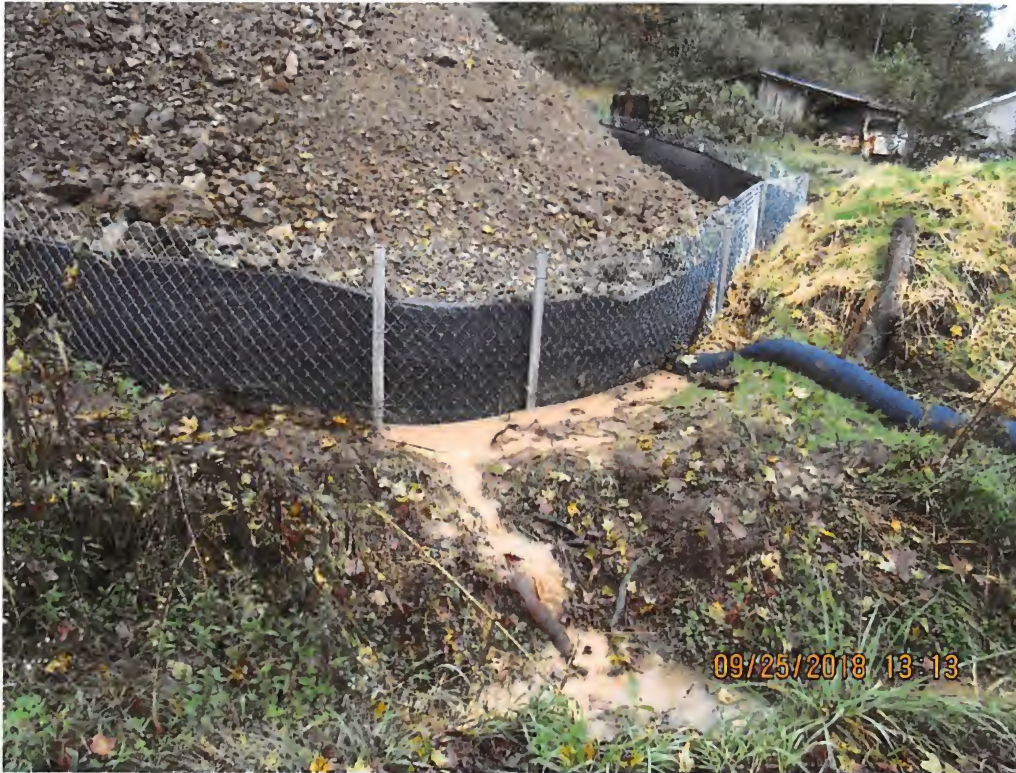
Photo 2: Undermined perimeter controls near 3634+00 which failed allowing sediment laden water to leave site.

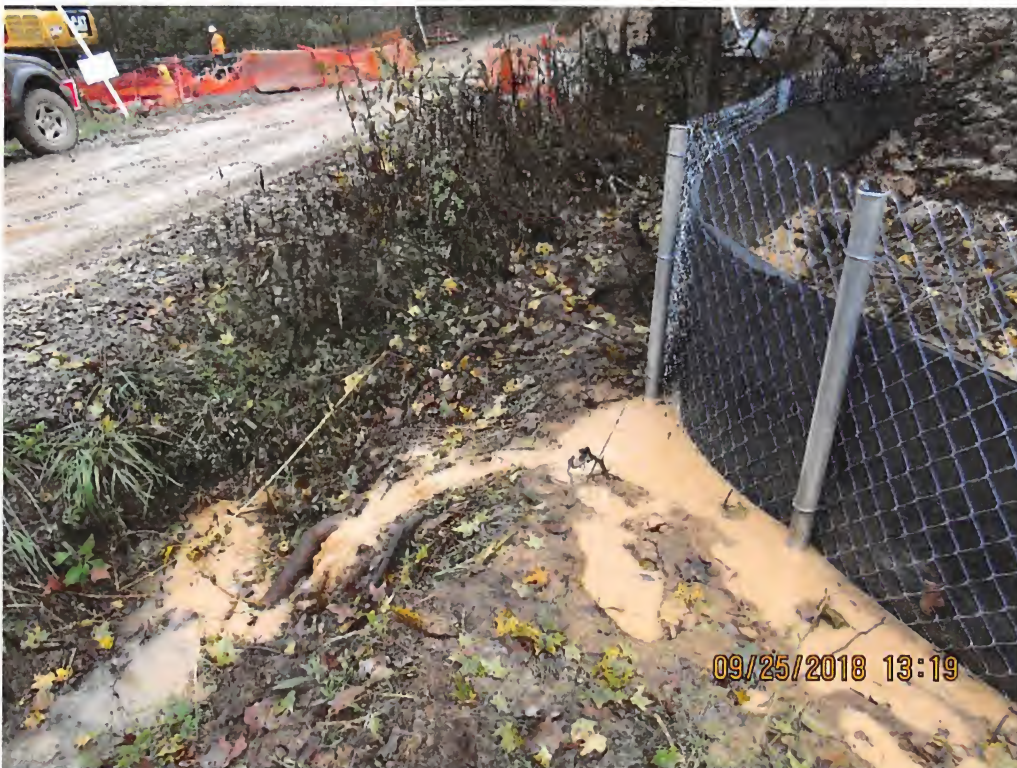
Photo 3: Failure of perimeter controls near 3634+00 allowing sediment laden water to leave site.

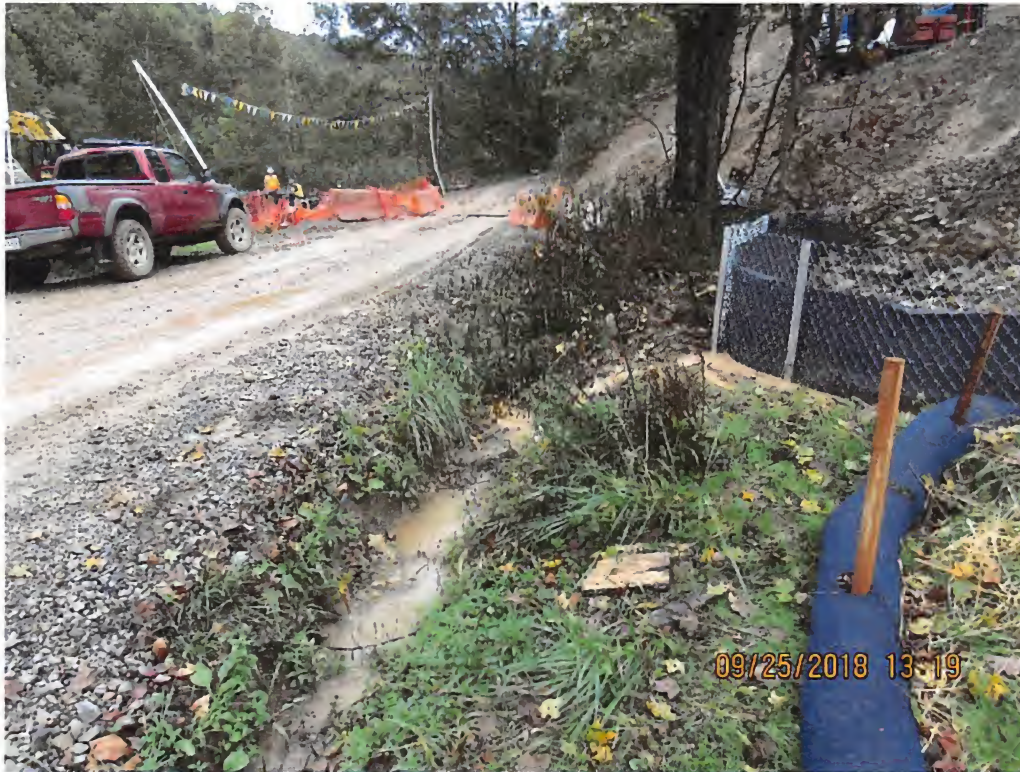
Photo 4: Close-up of failed perimeter controls near station 3634+00 where sediment laden water is entering UNT of Knawls Creek.
